## **Public Disclosure Regarding Kevitsa Tailings Facility**

2023-07-24

## I. INTRODUCTION

## 1 DESCRIPTION OF THE TAILINGS FACILITY

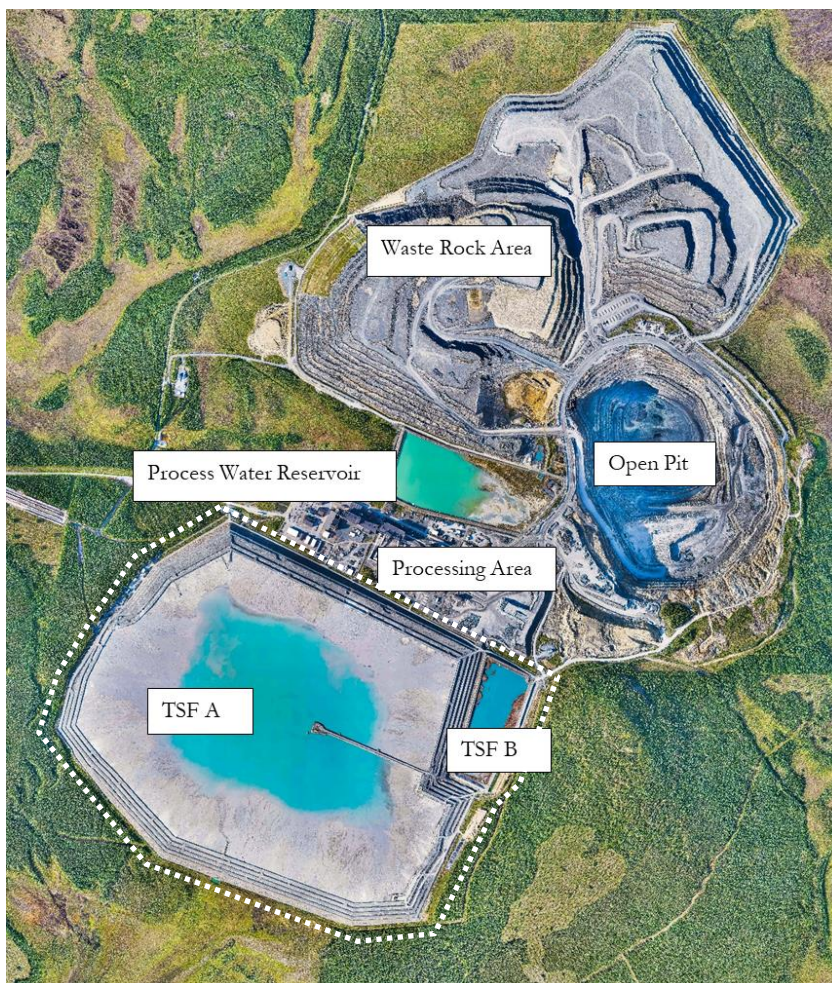
**Figure 2** Aerial photo (2022) of the Kevitsa mine – The tailings facility area marked with a dotted line

**Figure 2** shows the location of the main structures within the mining area while **Table 1** provides a summary of the tailings and water management structures. See Section 5 for a more detailed description.
