## Public Disclosure Regarding Hötjärn Tailings Facility and Gillervattnets Tailings Facility

Approved by:  
Anna Åberg  
Dam Safety Accountable Boliden Area –  
Hötjärn TSF and Gillervattnet TSF

This document provides additional information specifically related to Hötjärn tailings facility and Gillervattnet tailings facility to fully provide the required information.

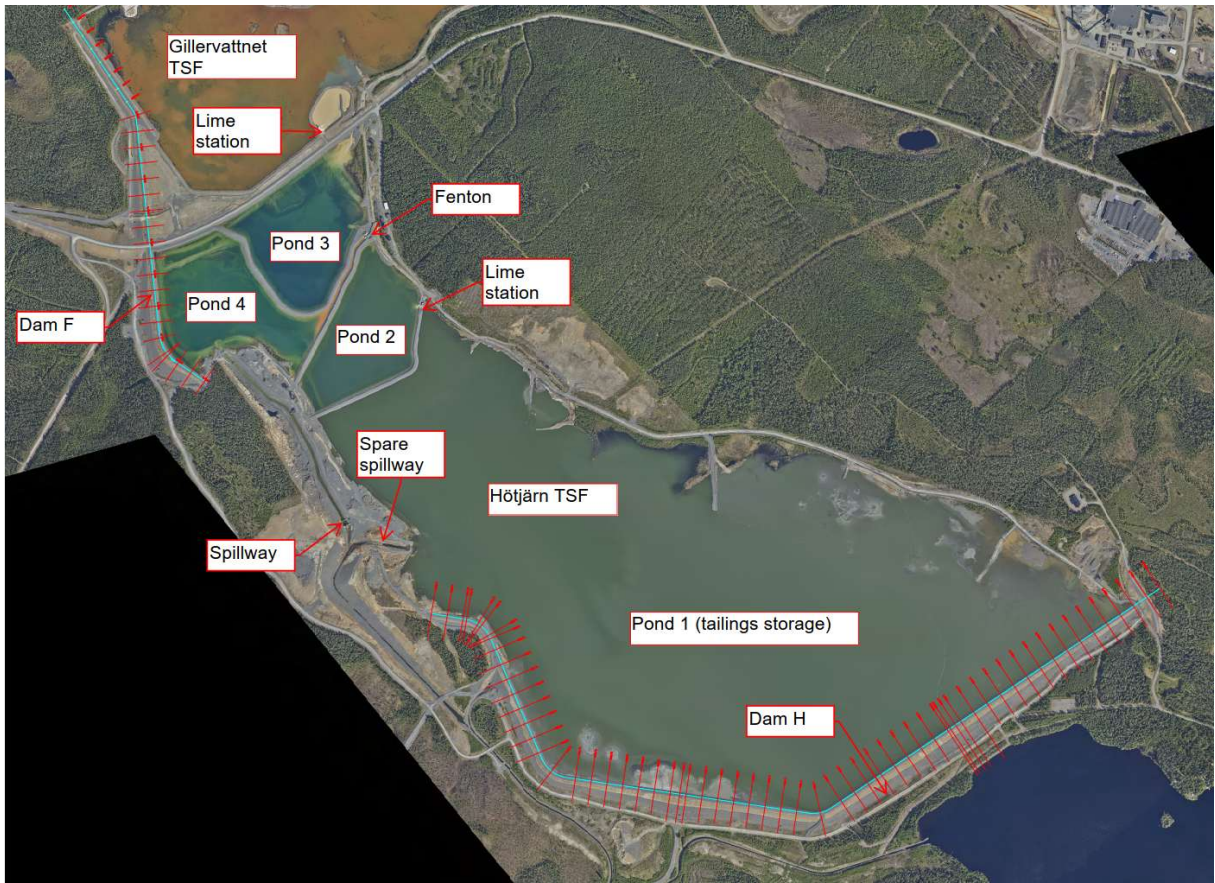
Figure 3 Aerial photo (June 2022) of the Hötjärn tailings facility

The tailings facilities consists of Gillervattnet TSF and Hötjärn TSF which are connected, see **Figure 2 and 3** for an aerial photo, and **Table 1** for a description of the main structures. Runoff water is flowing from Gillervattnet TSF by gravity through a culvert under road 857 to Hötjärn TSF.

The tailings have a rather high sulfide content and vary depending on which ore being processed. Therefor Boliden uses subaqueous depositing in Hötjärn tailings pond 1 to seal the tailings from oxygen with a water cover and prevent the development of acid rock drainage. For more information regarding the dams, see Chapter 5.
