Public Disclosure Regarding Garpenberg Tailings Facility

2025-08-01

1. Description of the tailings facility

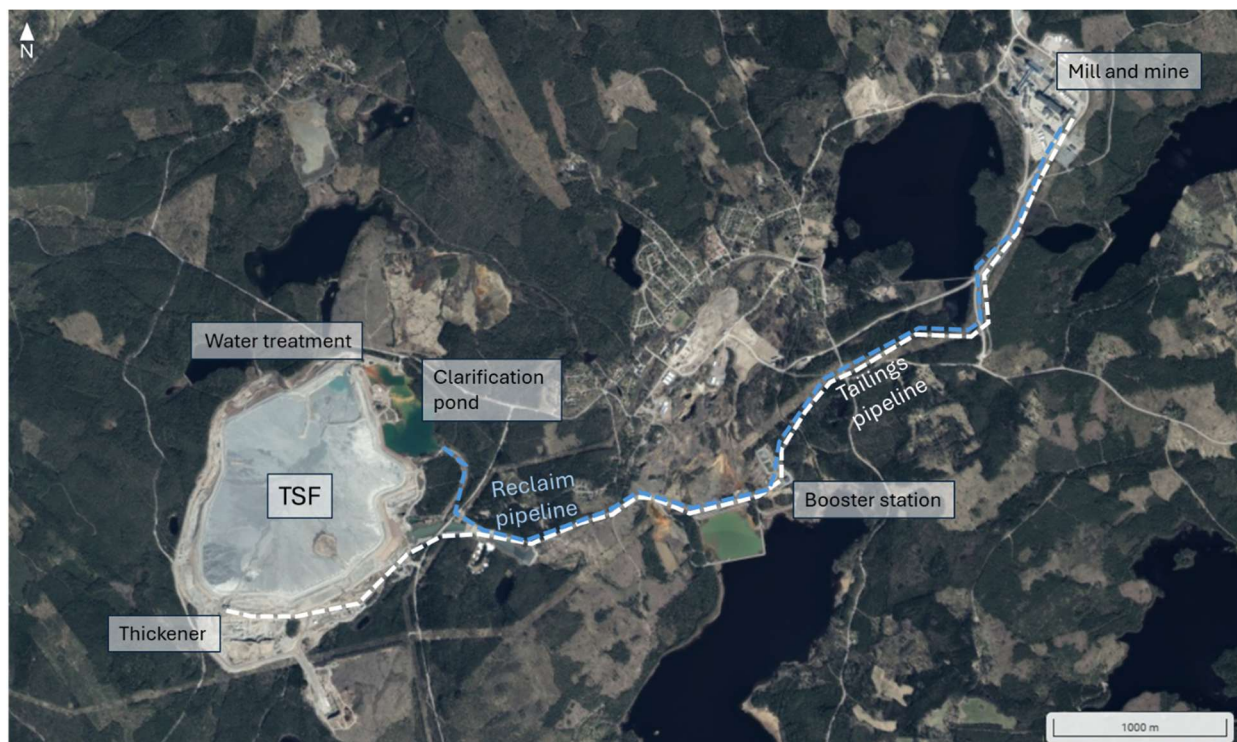
Figure 2 Aerial photo of the Garpenberg mine, mill, and tailings facility.

Tailings are deposited in the tailings storage facility (TSF), colloquially called Ryllshyttan, located around 5 km southwest of the mill site, see Figure 2. After cycloning of the total tailings to use part of the stream for backfill in the mine, the remainder of the tailings stream is pumped to the tailings facility with the help of a booster station located between the concentrator and the TSF.

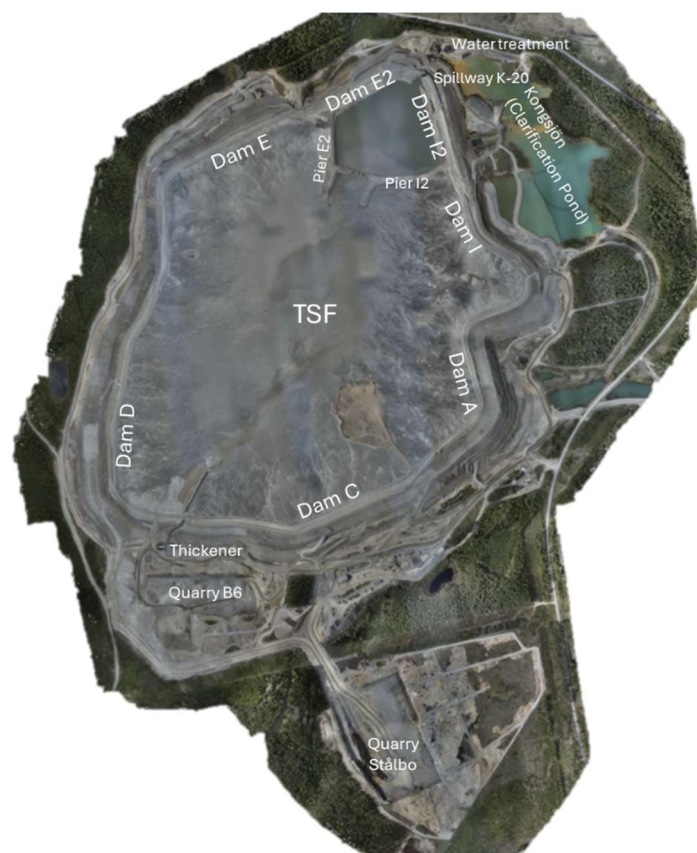
Figure 3 Aerial photo (Maj 2025) of the Garpenberg tailings facility.

The facility consists of a tailings storage facility and a clarification pond, see Figure 3 for an overview and Table 1 for a description. The slurry is dewatered using a high rate thickener to a solids content of ~33 % and spigotted on the beaches around the whole facility. Deposited tailings are used for constructing the dam raises. The rate of rise is around 1 m per year.

Overflow from the thickener is discharged in the center of the facility. Water from the facility is treated before discharge to the clarification pond, where fines are allowed to settle. At the spillway from the clarification pond, 85-90 % of the water is reclaimed for use in the concentrator. For more information regarding the dams, see Chapter 5. Rockfill for construction originates from quarries located near the facility.
