Public Disclosure Regarding Luikonlahti Tailings Facility

Approved by:
Tom Söderman
Dam Safety Accountable Luikonlahti

1. Description of the tailings facility

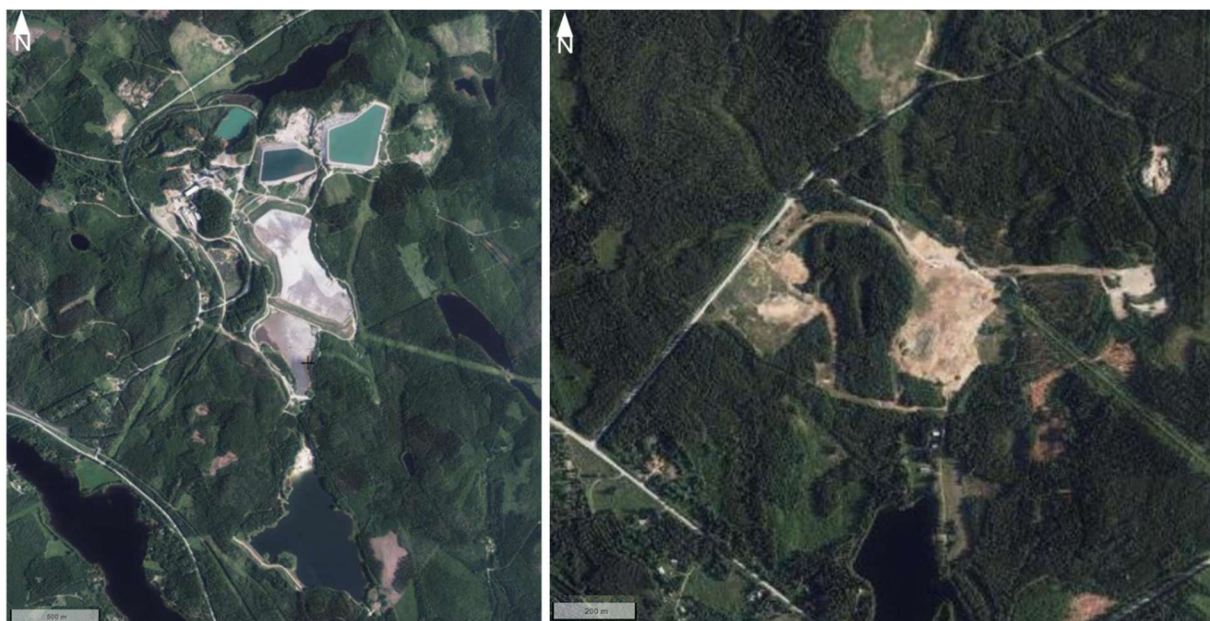
Figure 2 Aerial photo of the Luikonlahti mill site and Kylylahti mine site.

The mine was closed at the end of 2020 and has undergone remediation work that will continue into 2026 and beyond, see Figure 2 for an aerial photo of the mine site.

The mill operated until December 2020 and has since been in a Care & Maintenance phase. The TSF used for storing tailings from the milling process is located at the Luikonlahti mill site and is thus called Luikonlahti TSF, see Figure 2 for an aerial photo. The coordinates (latitude, longitude) of the main entrance to the mill site are 62°55'53"N 28°42'22"E. The TSF was in operation between 1968–2020 (with a hiatus between 2006–2011), storing tailings from multiple operators and concentration processes.

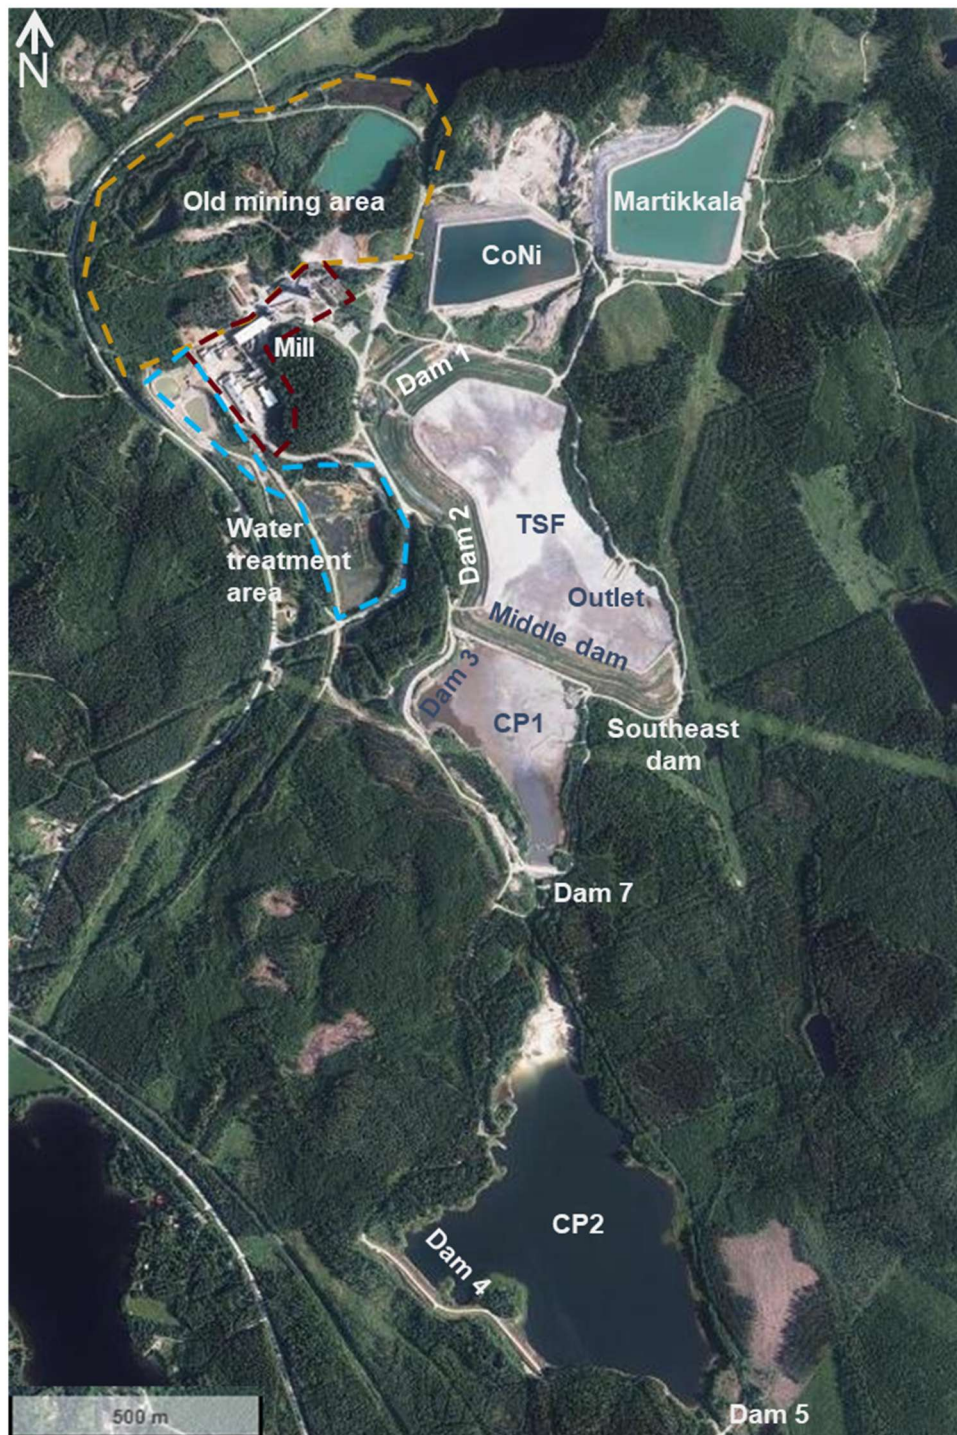
Figure 3 Aerial photo of the Luikonlahti mill area with the different ponds, dams, and areas marked.

At the mill site there are several structures disclosing a long mining history in the area. The overview in Figure 3 shows the old mine and mining structures, the mill, the TSF with subsequent clarification ponds CP1 and CP2, as well as the CoNi and Martikkala ponds. The last two (colloquially called CoNi-ponds together) are filled with a cobalt and nickel rich pre-concentrate that could be enriched to extract cobalt and nickel. Boliden does not regard these as tailings facilities in their current configuration. Water treatment areas are also shown in the figure.
