## Public Disclosure Regarding the Enemossen Facility

2025-08-01

Approved by:  
Peter Bergman  
Dam Safety Accountable Boliden -Zinkgruvan

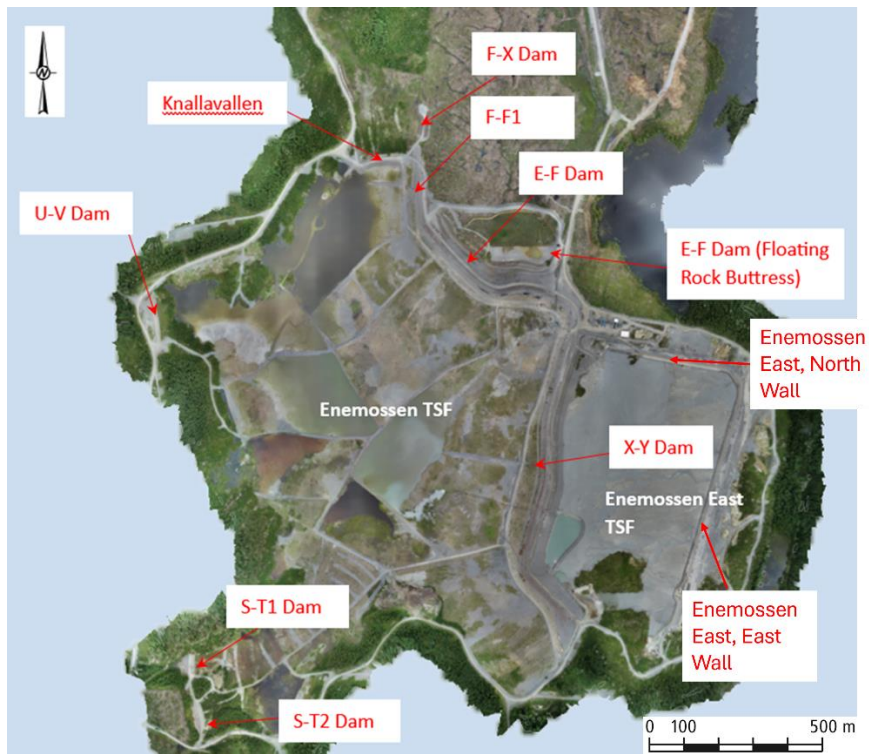
Figure 2 Aerial photo of the Enemossen and Enemossen East Tailings Facilities

The Enemossen consists of the Enemossen TSF, Enemossen East TSF and associated Clarification Pond, see Figure 2 and Figure 3 for aerial photos, and Table 1 for a description of the main structures. For more information regarding the dams, see Chapter 5.

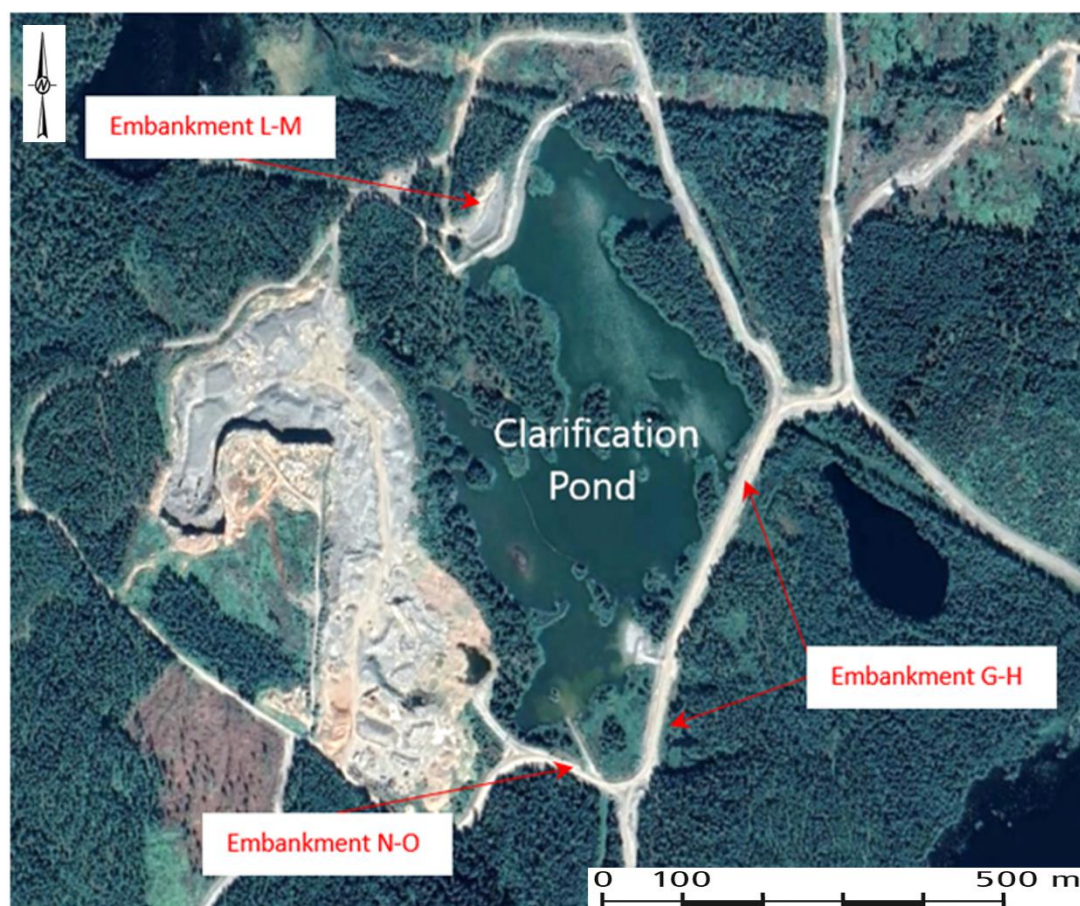
Figure 3 Aerial photo of the Clarification Pond
