Public Disclosure Regarding Kevitsa Tailings Facility

1 Description of the Tailings Facilities

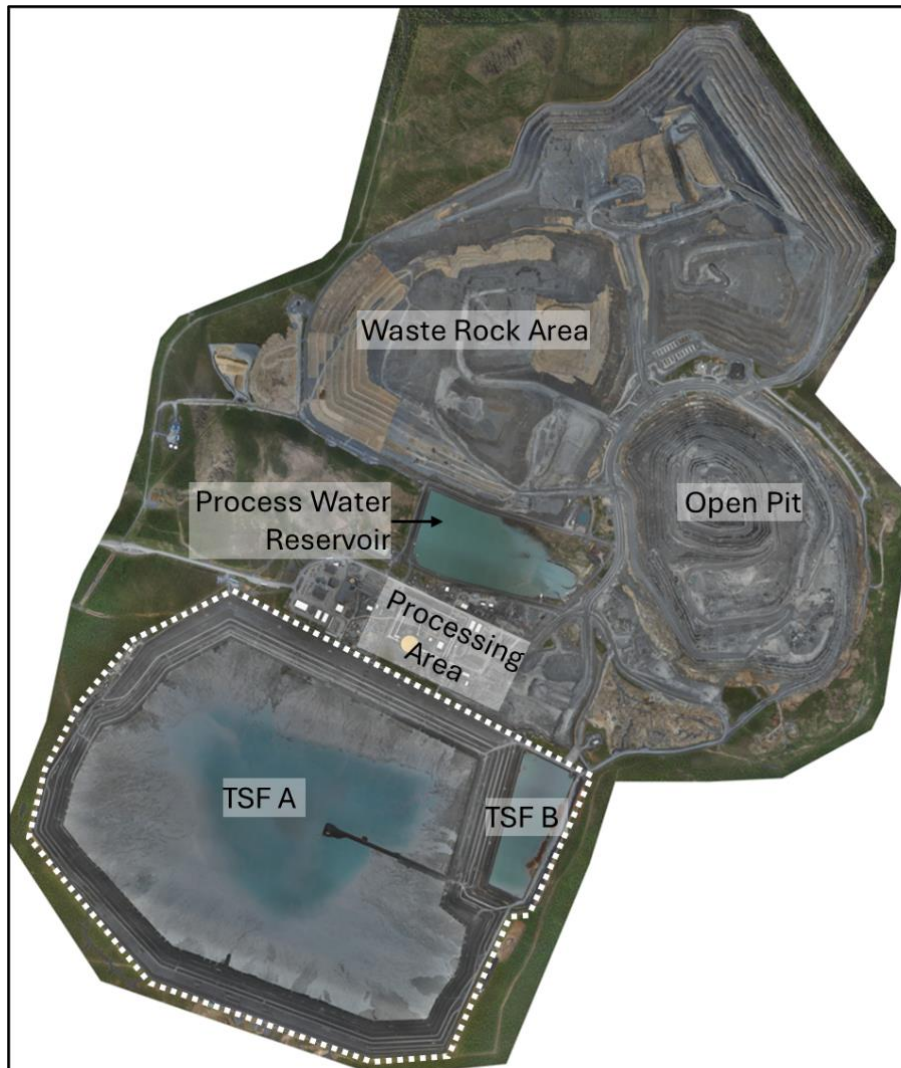
Figure 2 Aerial photo (2024) of the Kevitsa mine – The tailings facility area located within the dotted line

Figure 2 shows the location of the main structures within the mining area while Table 1 provides a summary of the tailings and water management structures. See Section 4 for a more detailed description.
